Paint Protection

Aids Customer Satisfaction, Improves RV Service Profits

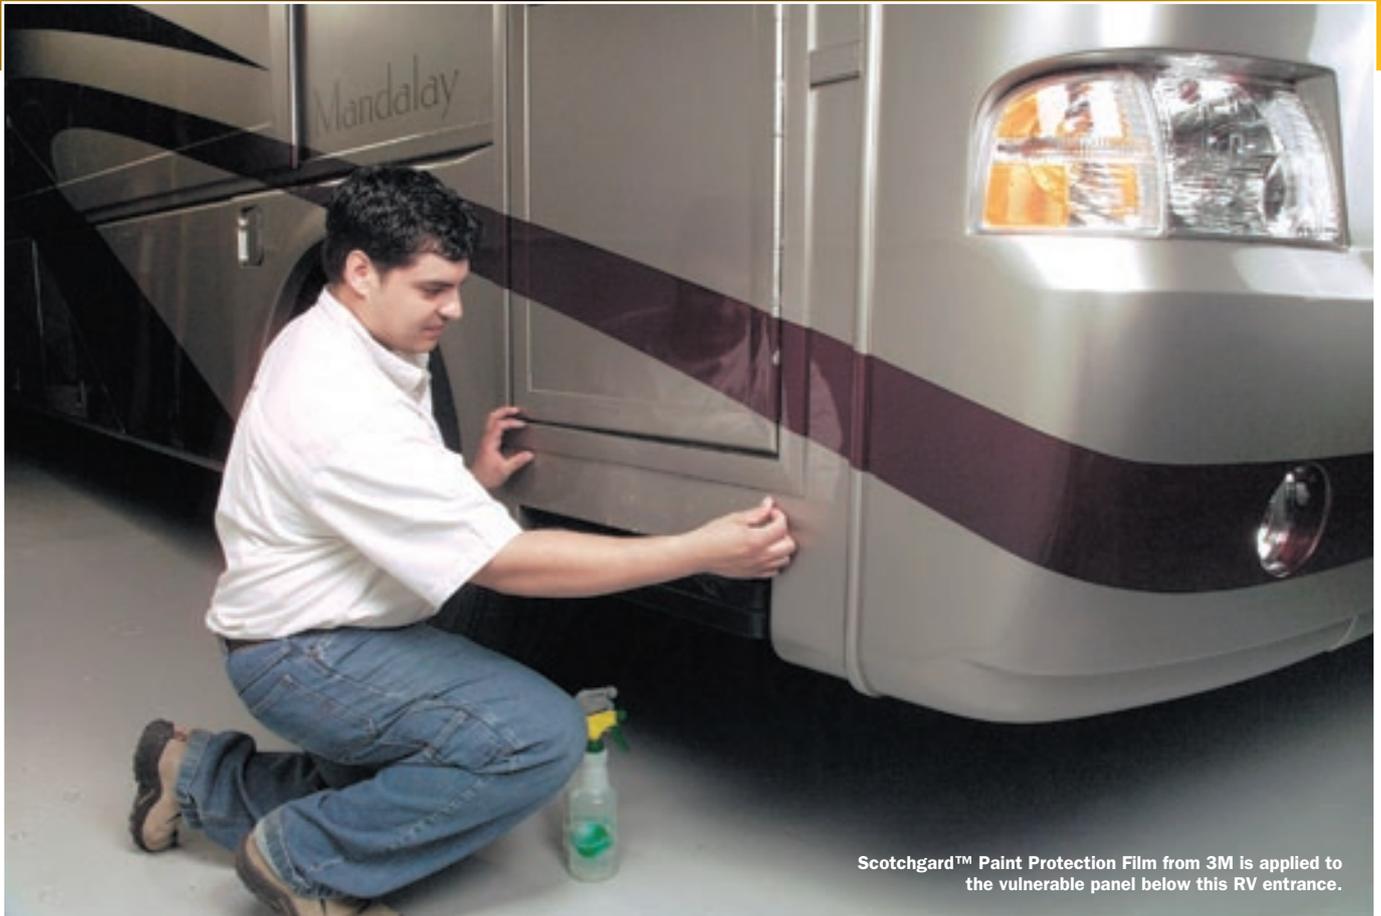
Scotchgard™ Paint Protection Film from 3M is applied to the vulnerable panel below this RV entrance.

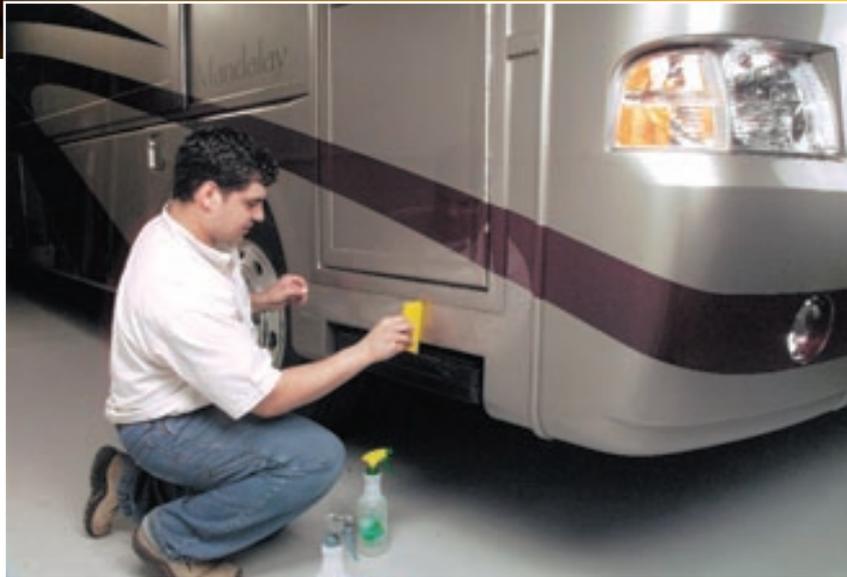
Film is smoothed and trapped air and water bubbles are removed from beneath the material using a flexible squeegee. With proper handling, the film conforms and adheres well, even on complex body shapes.

Paint protection film installation begins with careful cleaning and removal of dust, wax and oil residues from the RV surface, which is then wetted with a solution so that the film can be put in place and adjusted before it adheres. The liquid solution is then removed by squeegee to remove air bubbles and creases while bonding the film securely to the painted surface.

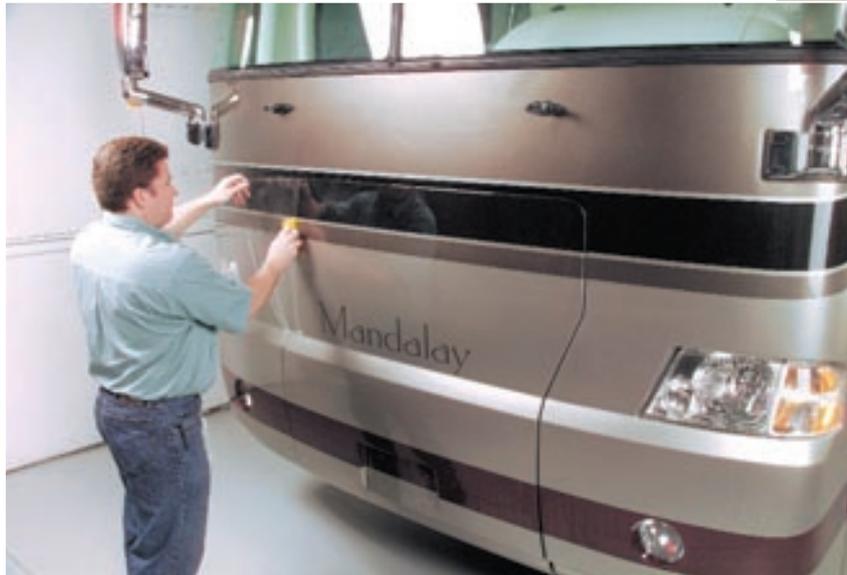
Very wide front panels on this RV are covered seamlessly with 40-inch-wide Scotchgard™ Paint Protection Film segments.

Film converters such as Coach Guard and Empire Clear Shield have developed pre-cut film kits that are customized to fit individual RV models for efficient installation. The film is also available from the manufacturer in roll form, and can be cut to fit the shape of the RV nose, bumper, window pillars, wheel well areas and other vulnerable painted surfaces.
